Manhole Inspection Summary

Manhole # S61Q__004MH

Insp Date: **12/17/08 11:34 AM**

Location Address: **4900 S. Ponca St.** Cross Street: **1200 Boston St.**

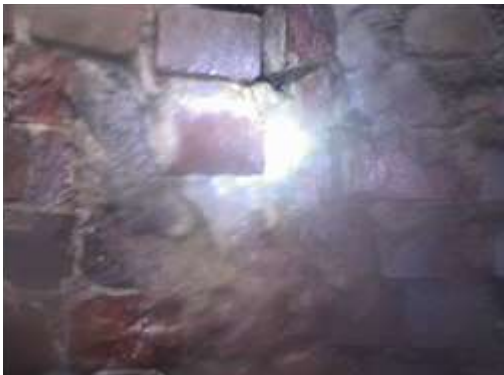
Defect 2

missing bricks in chimney

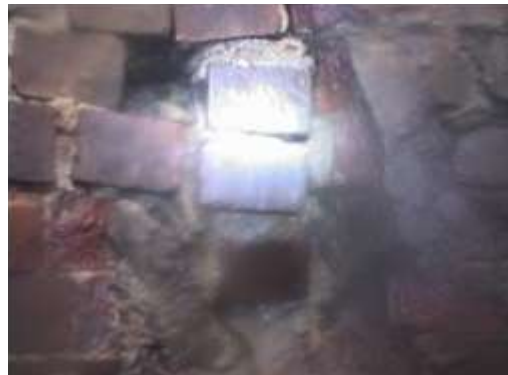
Defect 3

Comments **HIGH TRAFFIC IN THE MIDDLE OF AN 4 WAY INTERSECTION. wall, mortar, joints, bricks falling in to manhole**

wall, mortar, joints, bricks falling in.

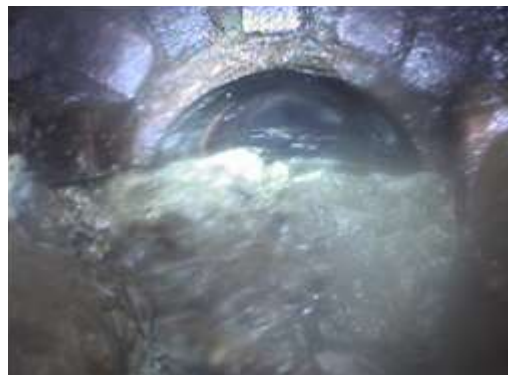
Defect 1

Debris in channel of I3

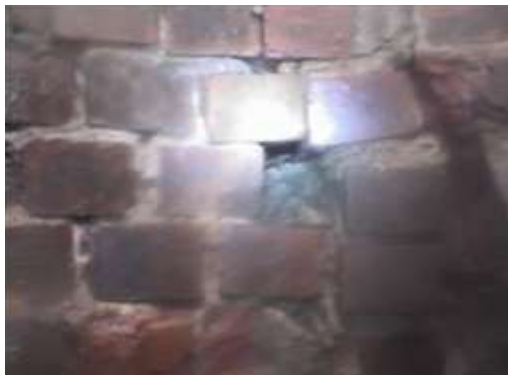
Defect 4

missing mortar

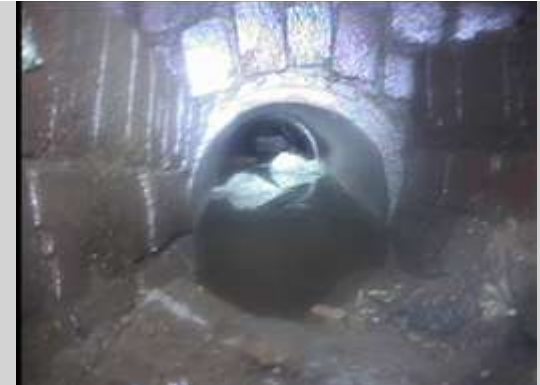
12 O'Clock Outflow

Pipe Height: **10.8** (in.) Rod and Bar (Angled)
Pipe Material: **Clay** ☐ Pipe Lined
Invert Depth: **11.67** (ft.) Flow Characteristics: **Slow**
Deposits: ☐ None ☐ Mud ☒ Sludge ☒ Debris ☐ Grease
Silt Depth: **0.5** (in.) Deposits Extent: **Medium**
Infiltration: **Evidence** Pipe Seal Cond: **Cracked**

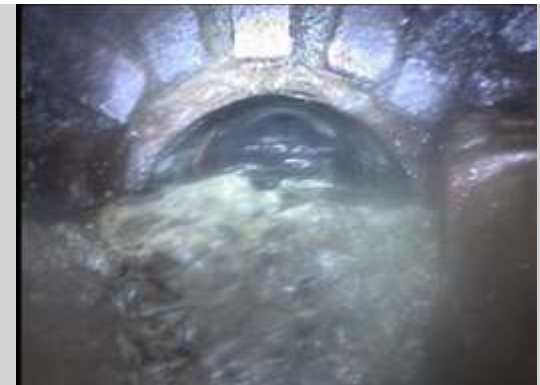
3 O'Clock Inflow

Pipe Height: **10.8** (in.) Rod and Bar (Angled)
Pipe Material: **Clay** ☐ Pipe Lined
Invert Depth: **11.33** (ft.) Flow Characteristics: **Slow**
Deposits: ☐ None ☐ Mud ☒ Sludge ☒ Debris ☒ Grease
Silt Depth: **6** (in.) Deposits Extent: **Heavy**
Infiltration: **None** Pipe Seal Cond: **Sound**
